ELEVATOR PHOTOS

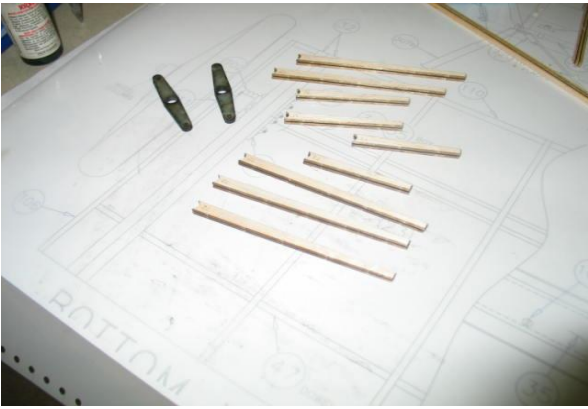
Rib parts ready to be glued together

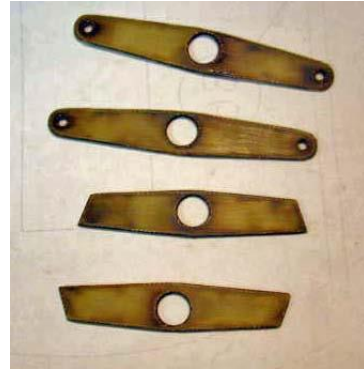
Control horn pieces ready for glue

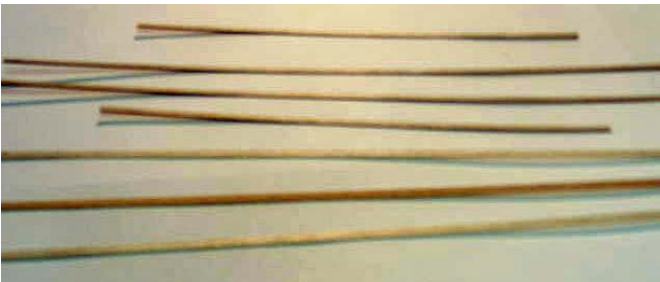
Plywood and balsa outline parts

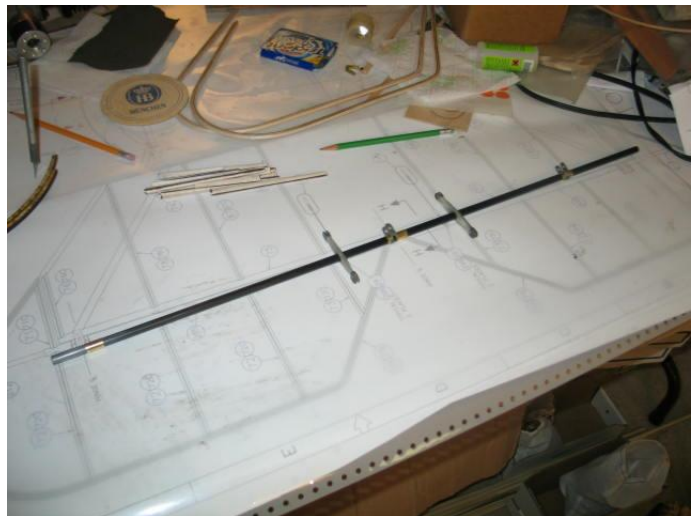
Brass tube, hinges, ctrl horns on carbon tube

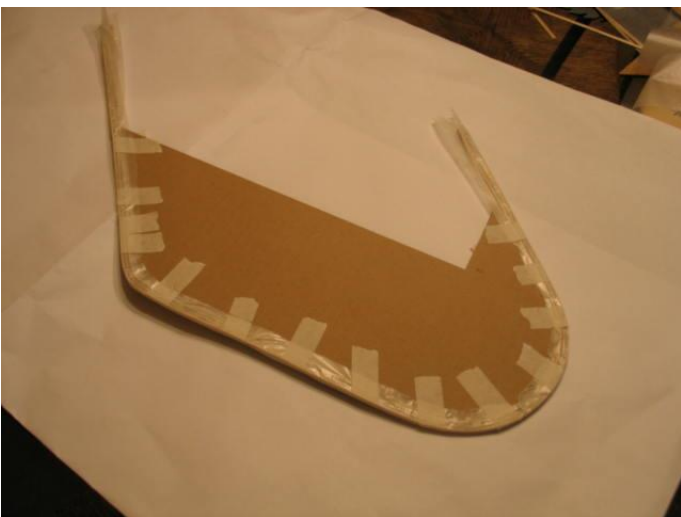
Laminated outline parts taped in place

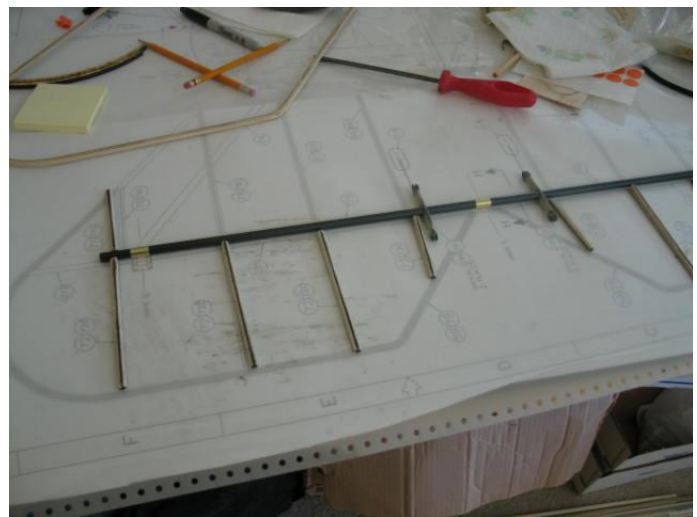
Ribs test fitted in position

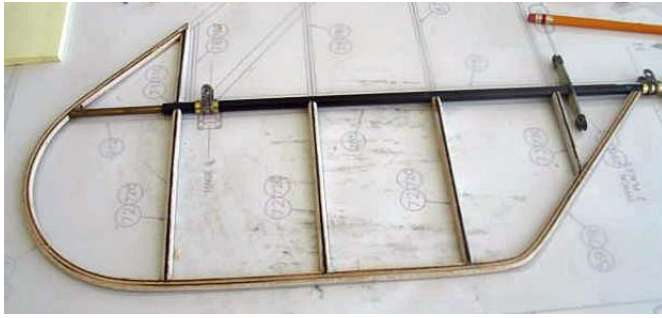
Outline glued in position, ctrl horn is next

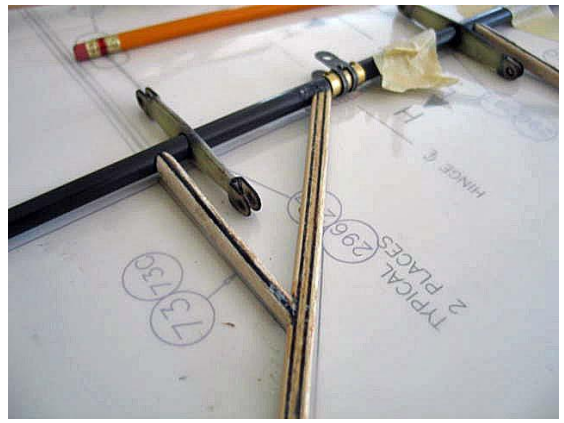
Close-up of inner rib to outline

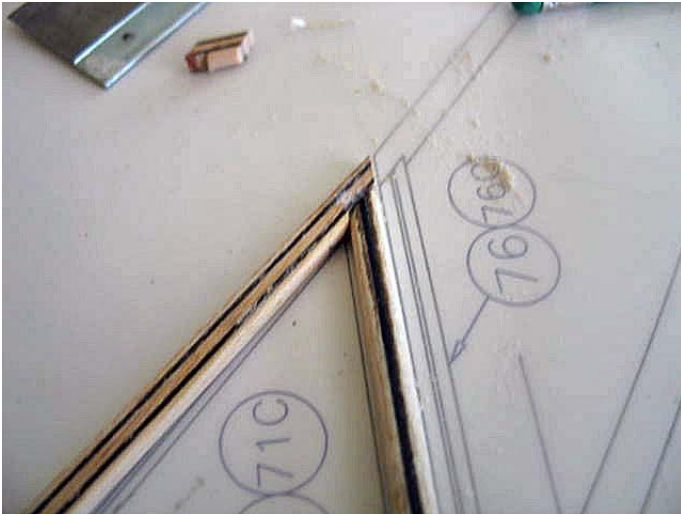
Close up of elevator tip

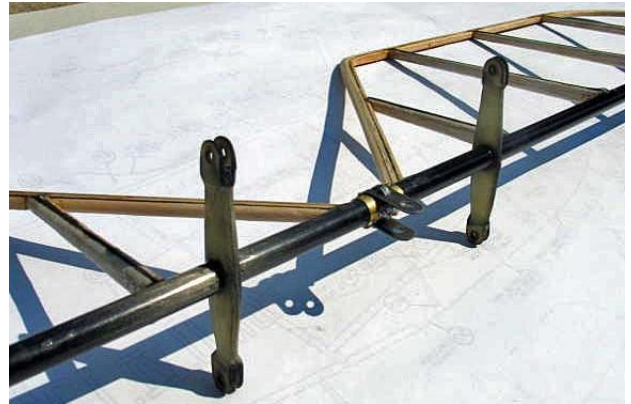
Control horns glued in place

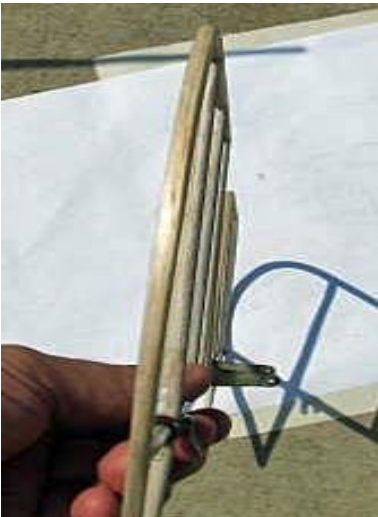
No warps

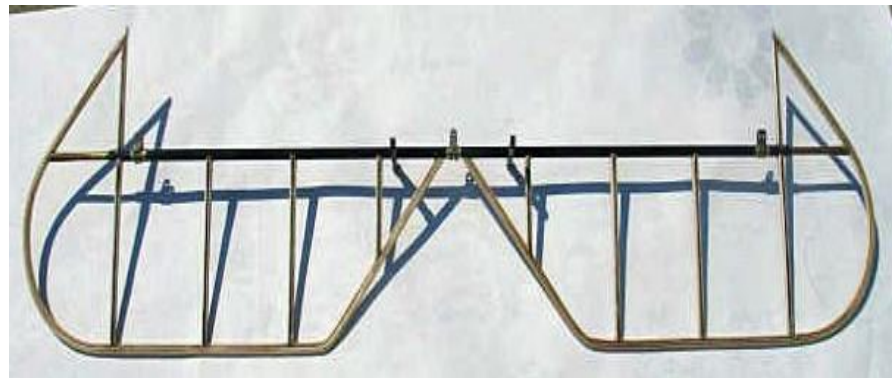
Completed elevator
