ELEVATOR PHOTOS

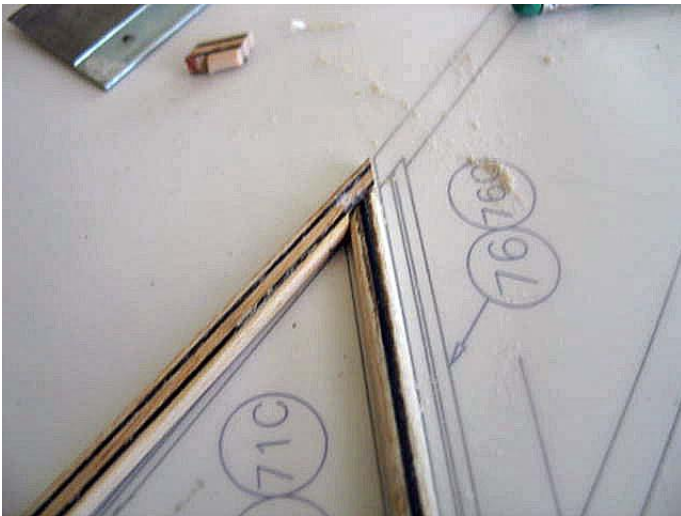
Close up of elevator tip

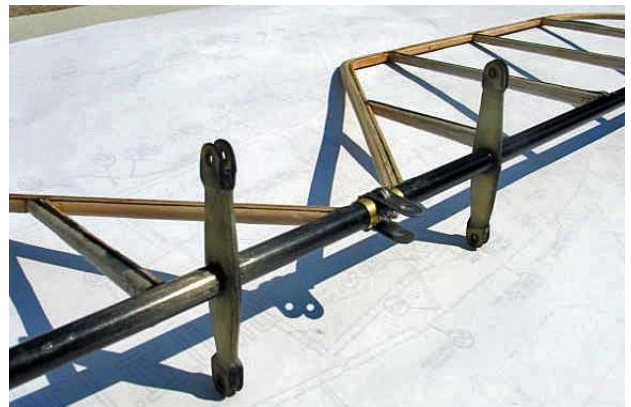
Control horns glued in place

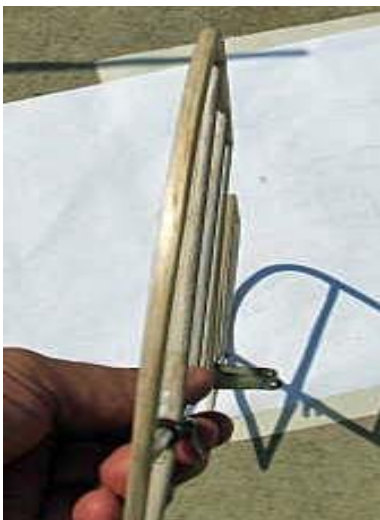
No warps

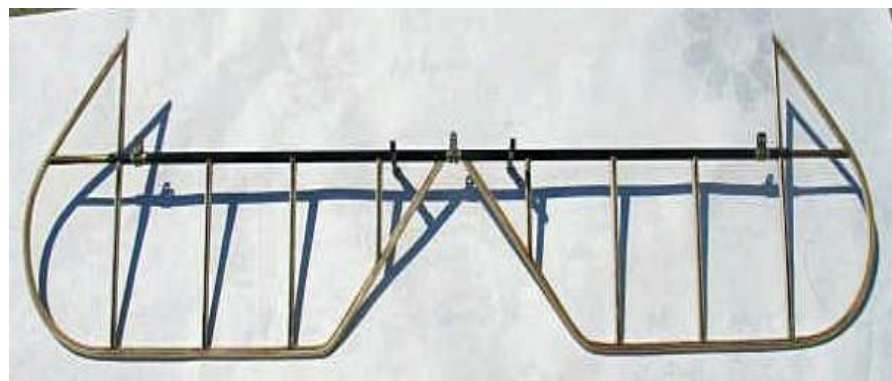
Completed elevator
